Dynastart – Hesitation Resolved

Bill Rogers

www.isettadoc.com

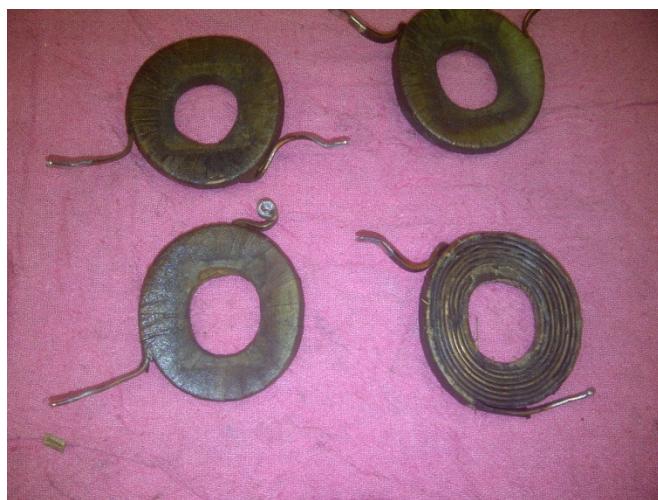
For about the past 14 years I have been assisting other Isetta and BMW 600 owners in restoring their drive-trains and brake to operating condition. In these years I have repeatedly run across one issue that has constantly baffled me. Why do some Isetta engines hesitate on the first revolution and then spin normally? The first thing that I look for when I would run across this situation is to eliminated the normal possibilities like shorted coils, bad solder joints and internal grounds. Many times I would find one or more of these issues and correct those deficiencies. But many times even after these issues were corrected, the dynastart just didn't seem to have the necessary torque to spin the engine over on the first revolution. Most of the time I would simply "write it off" as ageing insulation that breaks down under load allowing some loss of system efficiency. As seen in the next picture, it was not uncommon to see aged insulation that was cracking and missing some sections. The coil in the lower right of the picture is an extreme case!

There was just one problem with assuming that it can't be fixed, I can't stand to be defeated! Possessing a Bachelor's degree in Electrical Engineering and having a lot of experience with DC machines at work, I was determined to come up with a solution to this problem. So over the past few years I have spent a significant amount of time trying to resolve this issue and put it to bed for good. This has lead me to work through a number of issues with the dynastart. The first was to make my own replacement coils

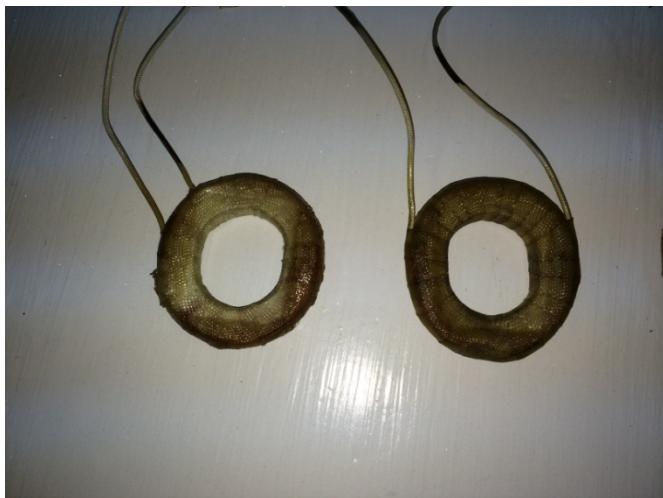
New generator field coils for Dynastart

for the generator section of the dynastarts. This seems to be the coils that are most often burned up and needing replacement. After trying to purchase these from various vendors only to find no one had any, I decided to start making them myself. After a couple of tries, I have perfected this process. This is the same process a motor repair shop would use. It would involve winding the coils on a mandrel, wrapping with motor insulation, dipping the coils in motor varnish, forming the coils to the contour of the dynastart housing and finally baking the coils to cure the varnish.

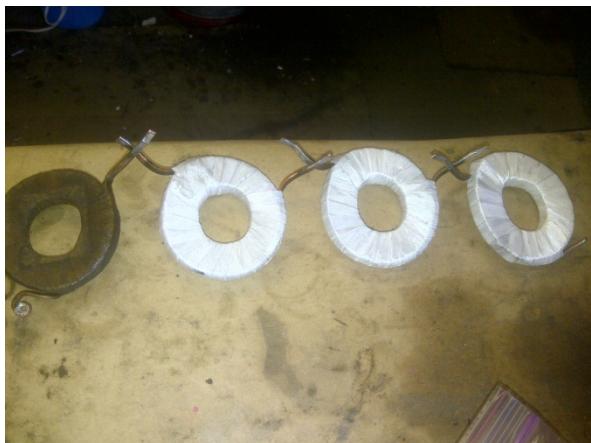
Three coils with new outer insulation

The next concern was there seemed to be many of these dynastarts that had damage to the outer insulation of the starting coils. Since I had already developed the process for making the generator coils – I decided that refurbishing the starting coils would be the next logical step. This also was a logical step in eliminating partial grounding issues as one of the possible concerns with the first revolution of the engine having its noted hesitation. I have also successfully accomplished this task as well, but even this didn't completely eliminate the hesitation issue.

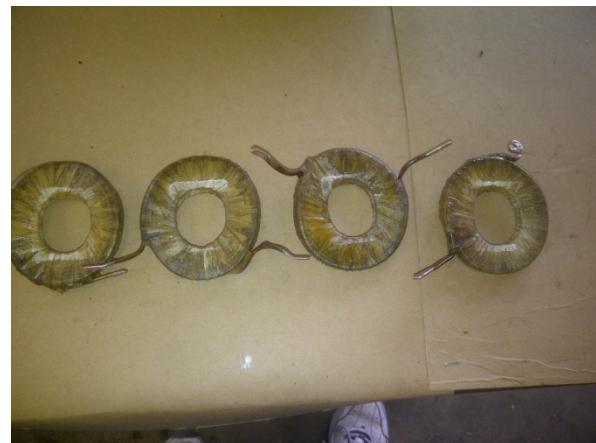
All coils wrapped, dipped and baked

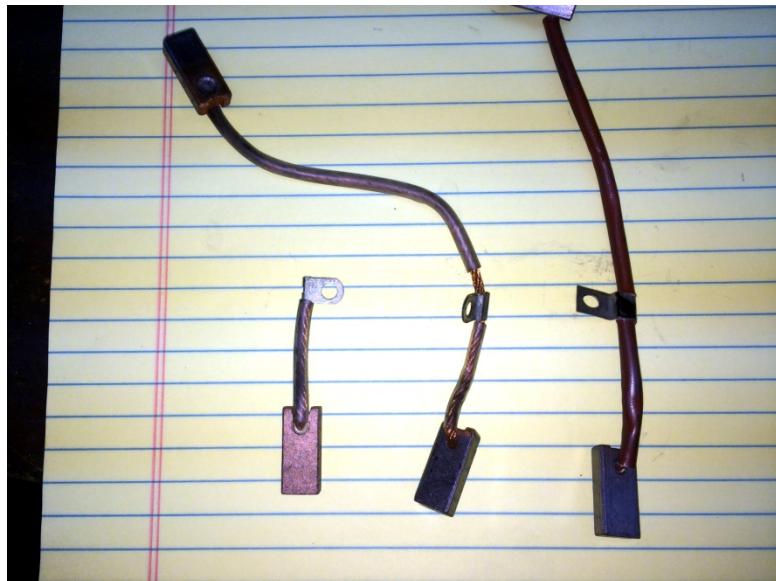
With all the work I do for various individuals, I frequently run across brushes that I know are original to the engine. I took one of these brushes and a brush that is currently available today and sent it to a brush company's laboratory for analysis. What they told me was no surprise since I was fairly sure by this time that there had to be a significant difference. Yes, the brush compounds were significantly different and the brushes used today have a considerably higher resistance than the ones used in the 1950s.

The motor brushes that are generally available from various suppliers are not the same as the brushes that were manufactured in the 1950s. My guess is that like many other things, substitutions have been made and the consequences of those substitutions are not always immediately realized. I for one hated to see this as I have about 60 sets of these modern brushes on my shelf that are now trash!

Below is a picture of the new brushes I have for sale and the modern substitutes that are being made available by most parts suppliers. The new brush is the one on the far left. It is somewhat difficult to see in the photo, but the one on the far left has more of a copper color than either of the other two.

I asked if they could duplicate the compound used in the brushes from the 1950 and the answer was positive. I had them manufacture a set of "test" brushes so I could actually see the difference it would produce on a customer's dynastart I currently had in the shop. Those brushes arrived a few weeks ago and the difference is amazing! The dynastart with the currently available brushes hesitated every time on the first revolution of the motor. The same dynastart with the "test" brushes in it spun the motor like a top!

Provided that you have corrected the other issues (solder connections, insulation condition, etc.) and are still having trouble with hesitation on the first rotation of the engine, I believe these new brushes will
