SPARK ADVANCE CALIBRATION

Bill Rogers

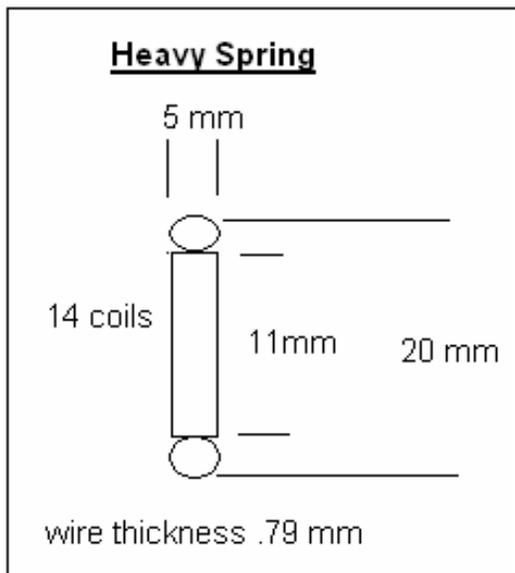
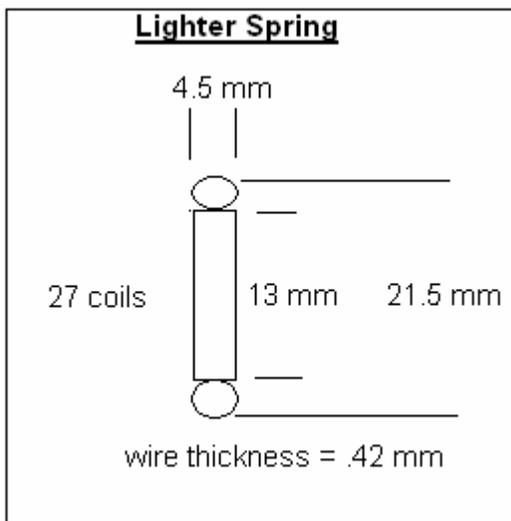
For most of us, a simple cleaning and re-lubrication of the advance unit is all that is necessary. In some remote cases, the advance unit springs may become damaged and require replacement. The advance unit on the 600 uses two different springs. The spring located near the tension plate (the adjustable plate mounted just above one of the springs on the advance) is much stronger than the other spring located on the opposite side of the advance. The stronger spring is very close in dimensions and resistance to the spring used on the Isetta 300. Below are the dimensions of the stronger and weaker springs:

Again, with stock springs, this adjustment should not be necessary unless someone has damaged one or both springs. If you are substituting springs, the Isetta 300 spring will work well for the heavier spring. If the lighter spring is damaged, McMaster Carr does have a spring that is close, but I have never purchased one. For your information the part number in the McMaster Carr catalog is **9044K15**. This spring is a made of a little heavier wire and has the following specifications:

Material	Steel Music Wire
Ends	Full Twist Loop
Length Inside Ends	7/8"
Outside Diameter	.180"
Outside Diameter Tolerance	±.002"
Wire Diameter	.018" (600's is .016")
Load	1.522 lbs.
Deflection at Load	1.120"
Deflection at Load Tolerance	±7.5%
Rate	1.080 lbs./inch
Rate Tolerance	±5%
Initial Tension	.317 lbs.

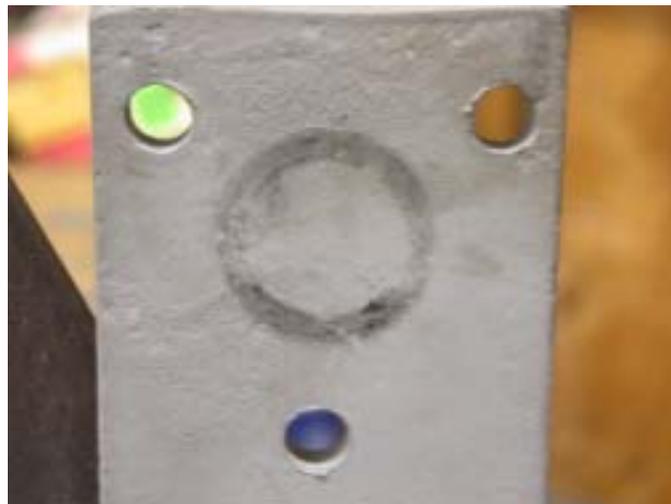
First you need some means to mount the advance unit so that the counter-weights and move freely. Since I had a number of advance units I needed to check, I decided to fabricate a bracket to hold the units. I made it from a scrap piece of 2" x 1/4" flat plate. I drilled three 1/4" diameter holes in the plate to hold the advance unit. The two holes at the top are 1 – 7/16" from center to center. The lower hole is exactly center of the upper holes and exactly 1 – 7/16" below the center line of the upper holes.

With the bracket mounted in a vice I bolted the advance unit to this bracket using (3) 6mm x 15mm cap screws.

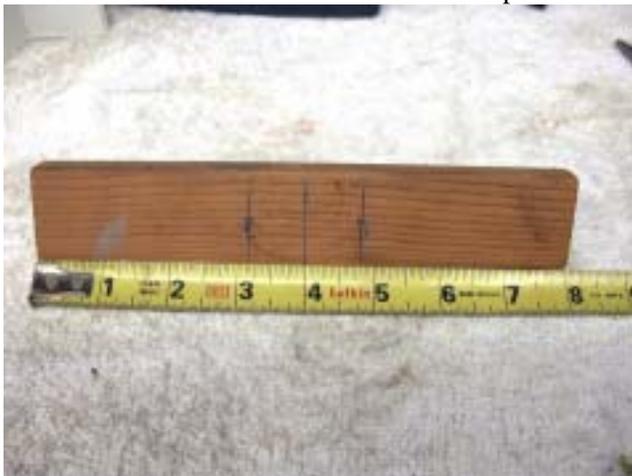
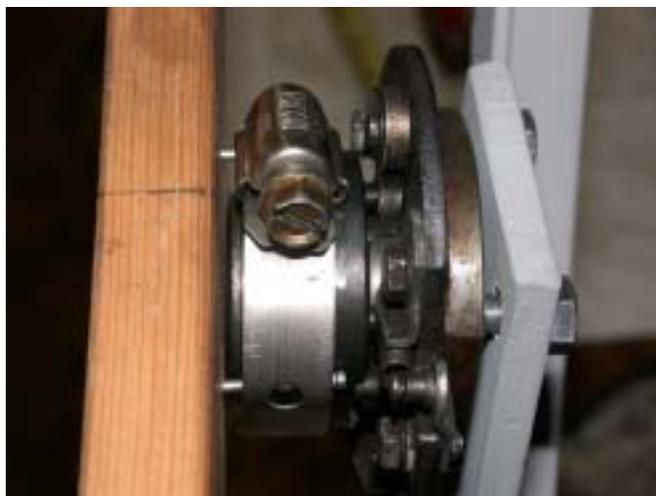
Now you need to make an arm for connecting either weights or a gauge to measure the resistance to movement. I used a 1 – 1/2" x 1/2" piece of wood 8" long. Measure the center of this piece very carefully and then measure in each direction away from the center exactly 13/16". Place two small finishing nails directly in the center of the board at these locations. See photo below:

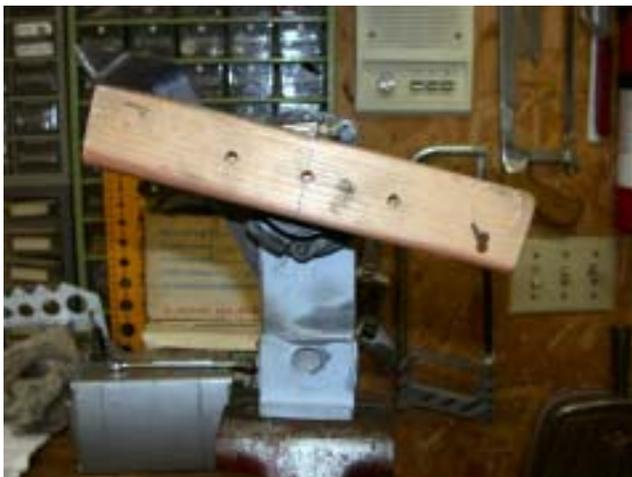
Prior to tightening the clamp completely, make sure the advance is in the full retard position. Adjust the board so that it is at an 11 degree incline as show in the picture on the next page. Full advance on the unit is 22 degrees. This will allow mid-advance to occur with the board exactly level.

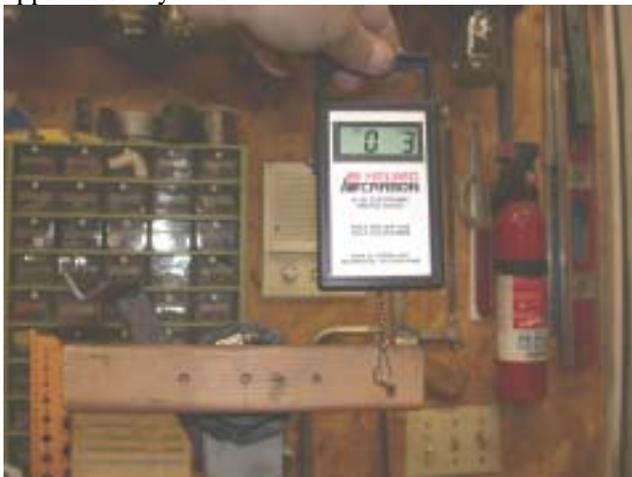
Now either using weights (on the left) or a spring gauge (on the right as shown in this document), check the amount of weight it takes to move the board to the "level" or 1/2 advance position. This should be approximately 3 oz.

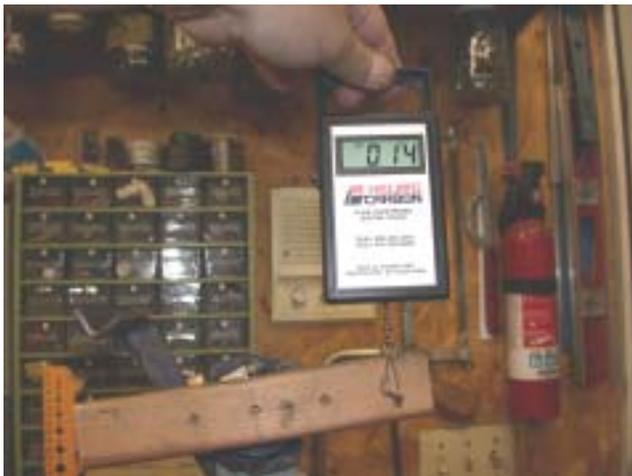
With the unit fully advanced it should require between 15 and 16 ozs of force.

If the unit is found to be out of calibration at the lower end try adjusting the lighter spring first. At the upper end the tension plate is the best adjustment to make. Once any adjustment is made, you should go back and check that the advance unit will return to the full retard position and that the other 2 positions are close to tolerance. I highly recommend you mark the unit prior to starting so that you can back out of any adjustment made if necessary. If you have only replaced one spring, I would suggest you not attempt to make any adjustments on the other springs adjustments unless it is absolutely necessary.
